Manhole Inspection Summary

Manhole # S29UU_008MH

Location Address: **3001 KESWICK ST**

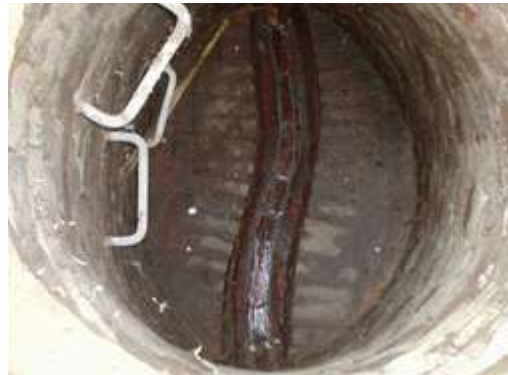
Top View

☐ Parged ☒ **Debris** (not Condition related)

Bench debris.

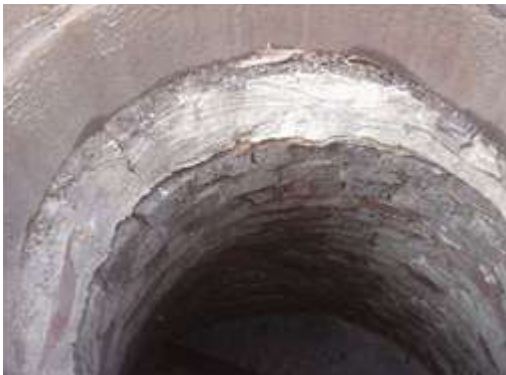
Defect

Condition: ☐ Sound ☐ Cracked ☒ **Leaks**

Condition: ☐ Sound ☐ Cracked ☐ Root Intrusion ☐ Loose Brick ☒ **Deteriorated**

Infiltration: ☐ None ☒ **Joint** ☐ Cracks ☐ Mortar ☐ Roots ☒ **Wall**

Infiltration: ☐ None ☐ Joint ☐ Cracks ☒ **Mortar** ☐ Roots ☒ **Wall**

Frame leaks. Adjustment deterioration and infiltration. Barrel infiltration - other side.

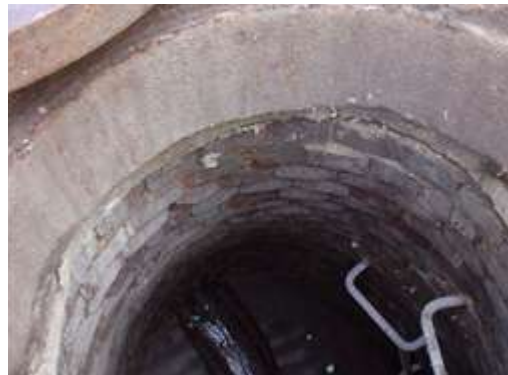
Defect

Frame leaks. Adjustment deterioration and infiltration. Barrel infiltration.

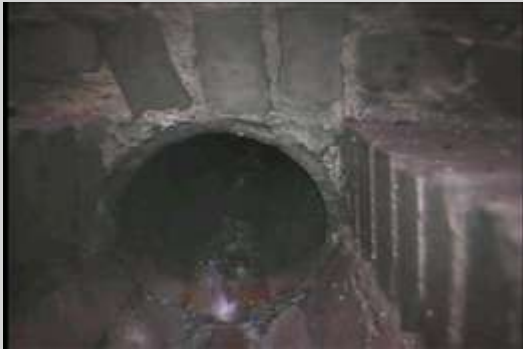
8 in. Circular Gravity Sewer Pipe Out @ 12 O'Clock

Infiltration: **Evidence** Pipe Seal Cond: **Unknown**

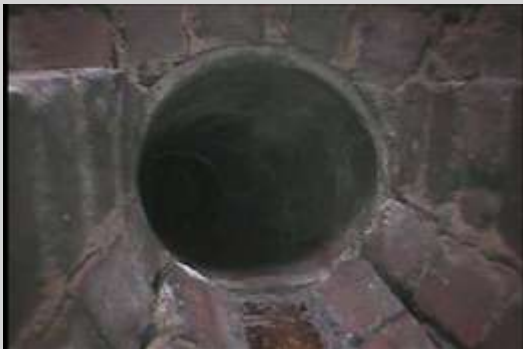
8 in. Circular Gravity Sewer Pipe In @ 6 O'Clock

Condition: ☐ Sound ☐ Cracked ☐ Root Intrusion ☒ **Deteriorated** ☐ Leaks ☐ Debris

Channel deterioration.

Infiltration: **Evidence** Pipe Seal Cond: **Unknown**
